DUCTILE PLATE TEARING BY CRACK TIP FLIPPING

KIM LAU NIELSEN

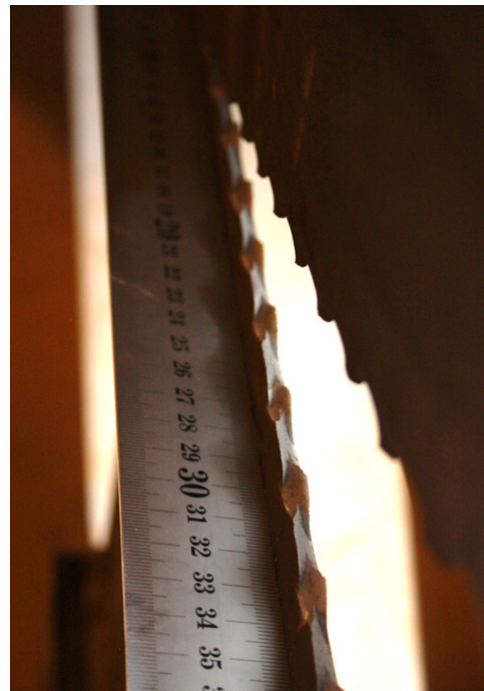
Figure 1: Repeated crack tip flipping in large scale testing of a normal strength steel plate subject to mode I loading.

ABSTRACT: Strong evidence exists that a number of unexplained transitions in crack surface morphology, that appears in mode I tearing of ductile plates, can be assigned to the so-called “crack tip flipping” mechanism, or element here of. But, little effort has been devoted to getting to the bottom of this intriguing plate tearing phenomenon despite numerous researchers reporting it. Crack tip flipping reveals itself when a slanted tearing crack, propagating in a ductile plate, shifts its orientation from one 45-degree angle shear band to the other. That is, the mechanics at play during crack tip flipping is strongly tied to the well-known slant crack propagation, where two equally active shear bands travel ahead of the leading tip, within a heavily strained region, such that plastic flow and damage evolution localize in one shear band and leaves the other band inactive. Figure 1 display a mode I crack that repeatedly flips back and forth in a very periodic manner and with high frequency – leaving a “shark teeth”-like surface. The flipping frequency is, however, dependent on the set-up (the constraints), the plate thickness, and plate material. High flipping frequencies are typical for steel, whereas the same tests performed on aluminum shows a lower flipping frequency. In fact, a slant crack can display flipping spaced apart on the fracture surface such that the slant crack has propagated some distance before making a new flip to the other 45-degree shear band. The mechanics involved are now understood to span multiple length scales – from the micro-mechanics governing ductile damage evolution, through the plastic flow localization into shear bands and thinning ahead of the crack tip, to the competition between the near tip plasticity and the far-field elastic plate response. A status on current insight to the crack tip flipping mechanism is given.
